HELICOPTER SECONDARY STRUCTURES  
RELIABILITY AND MAINTAINABILITY  
INVESTIGATION

Kenneth B. Krieger

United Aircraft Corporation

July 1974

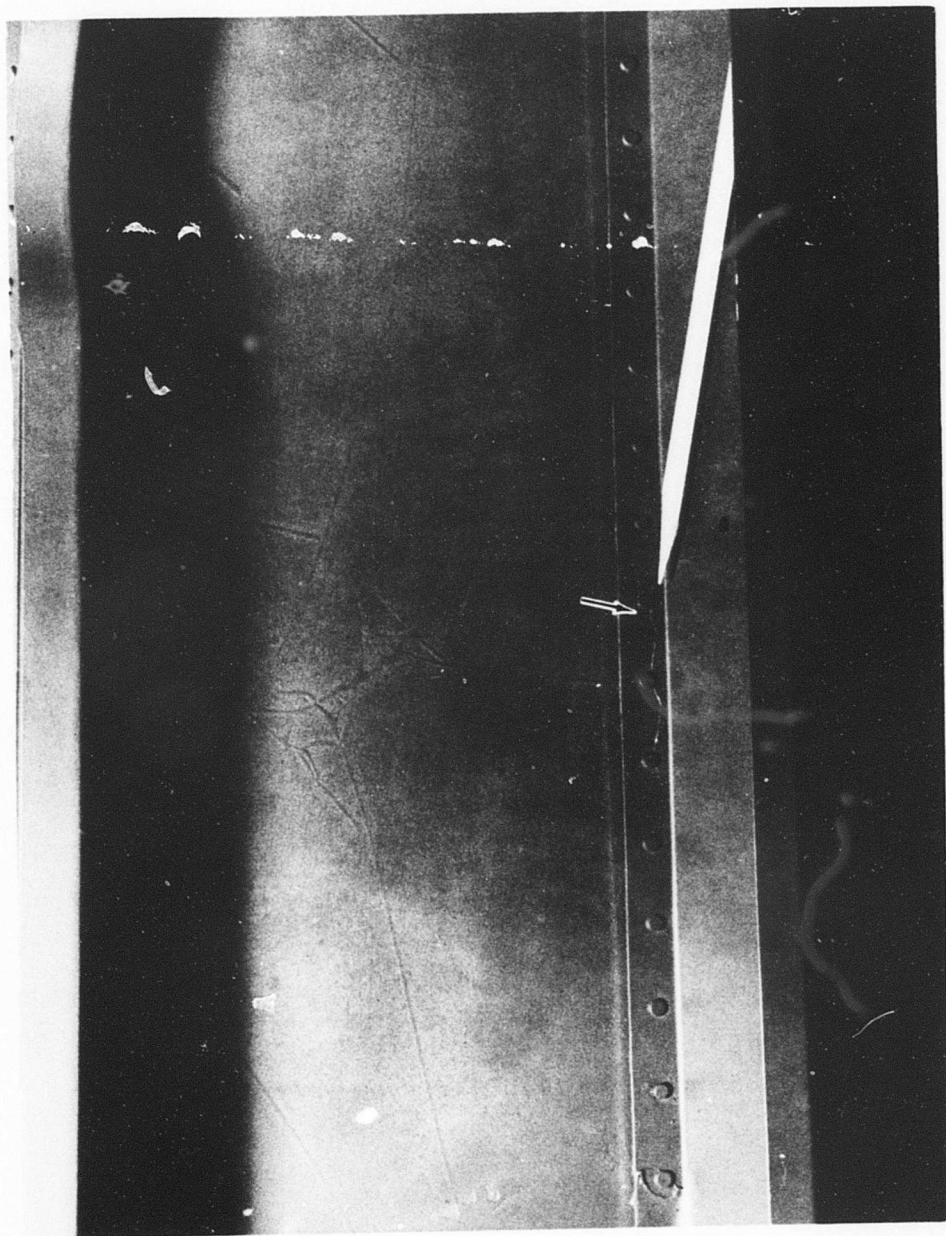
Figure 15. Main Rotor Pylon, Structural Damage, Vibratory Load.

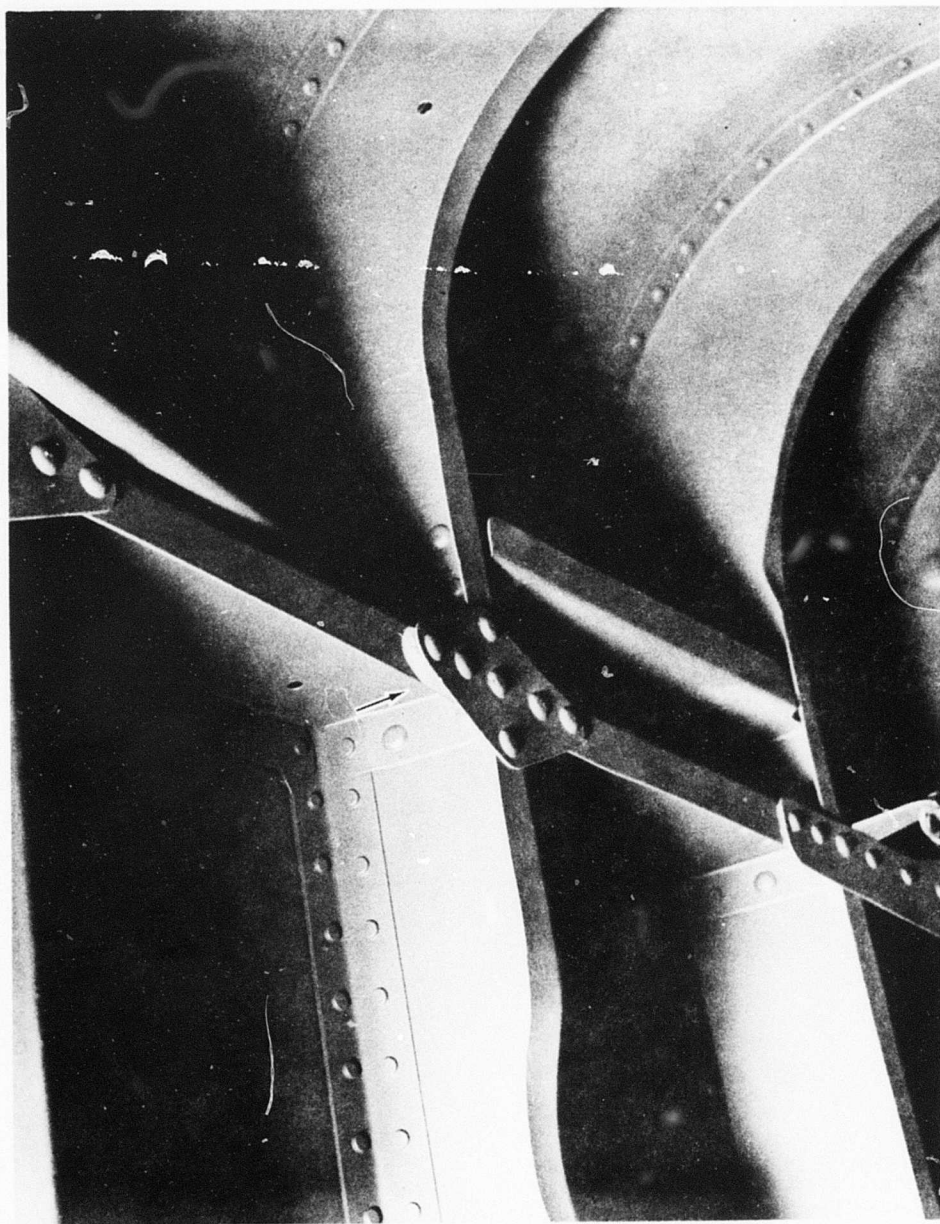
Figure 17. Main Rotor Pylon, Structural Damage, Popped Rivets.

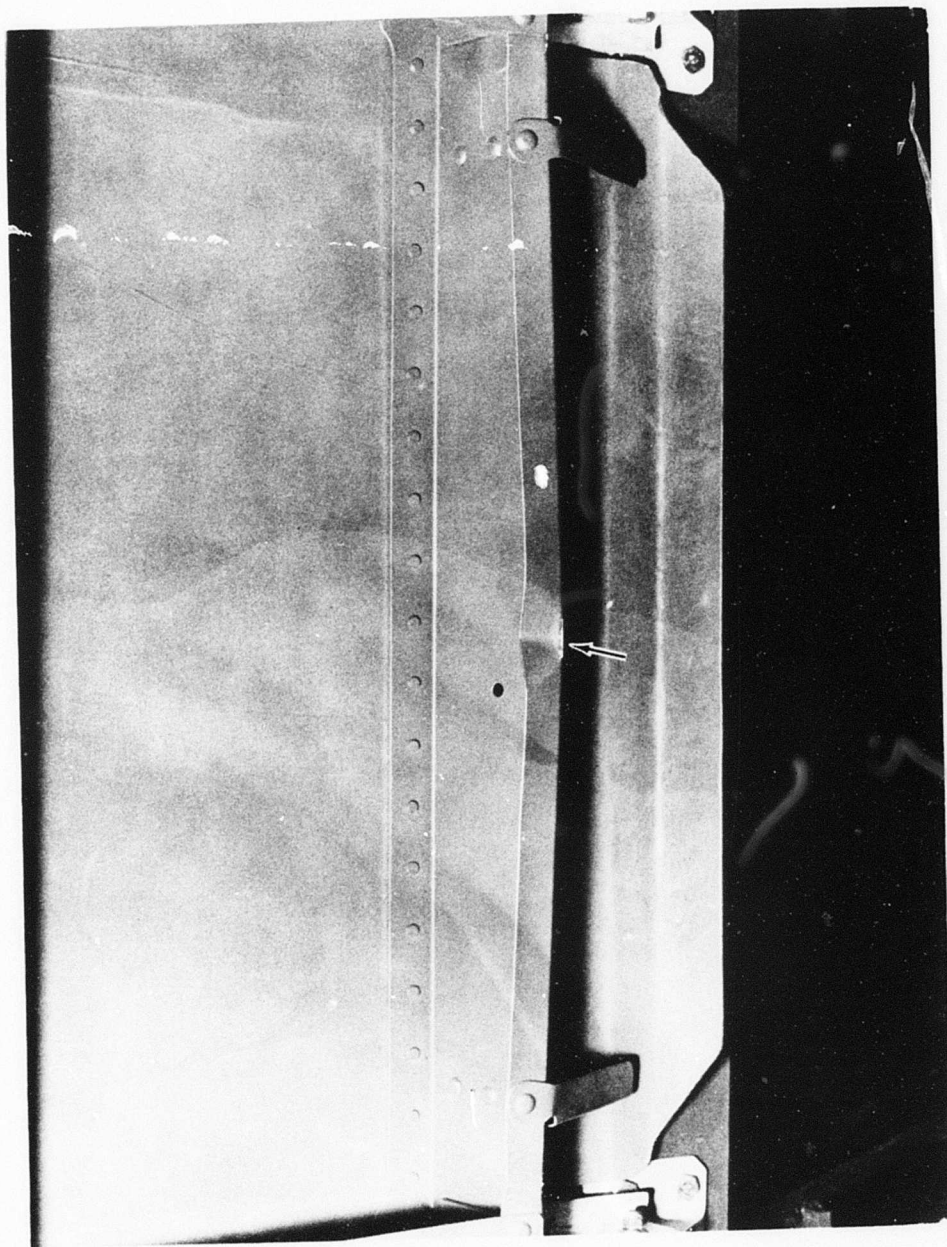
Figure 18. Main Rotor Pylon, Structural Damage, Buckled Stringer.

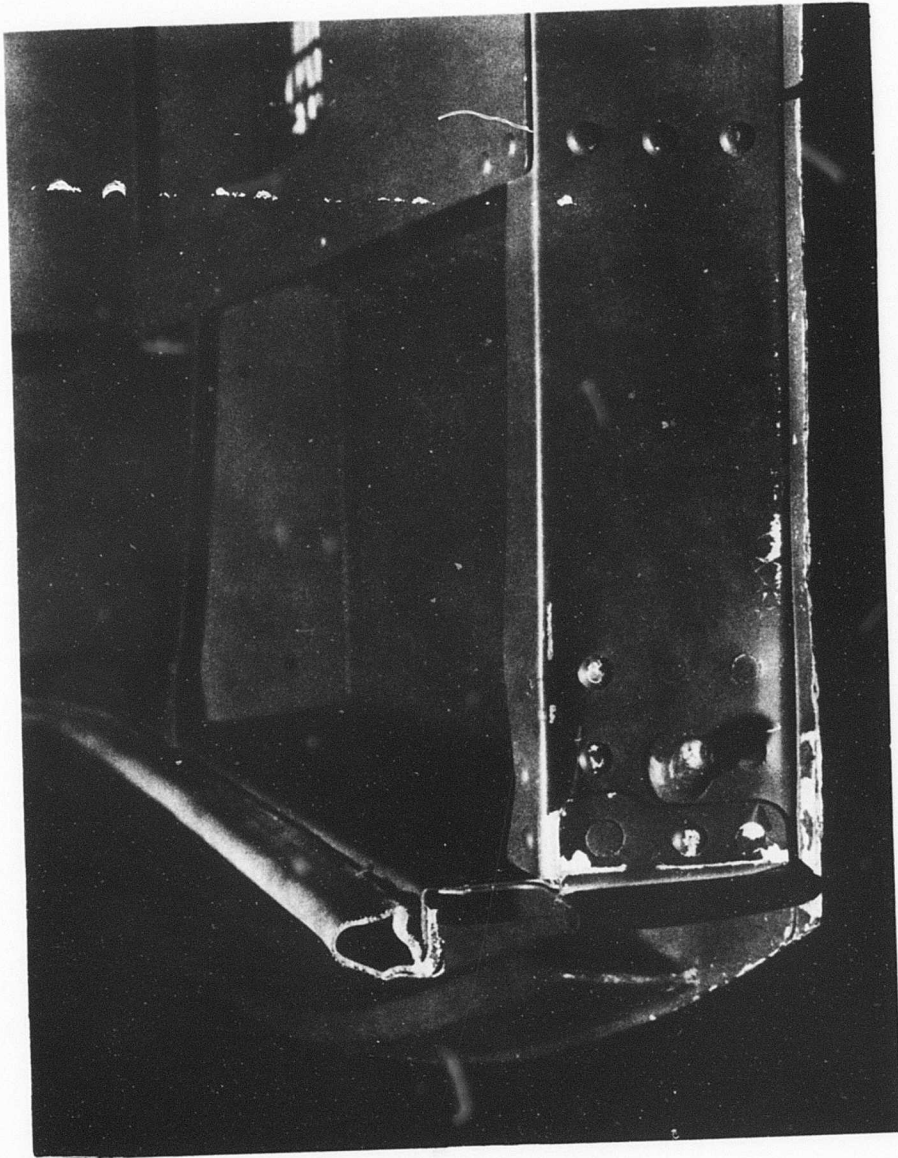
Figure 19. Main Rotor Pylon, Structural Damage  
(Lower Aft Corner Alignment Pin).

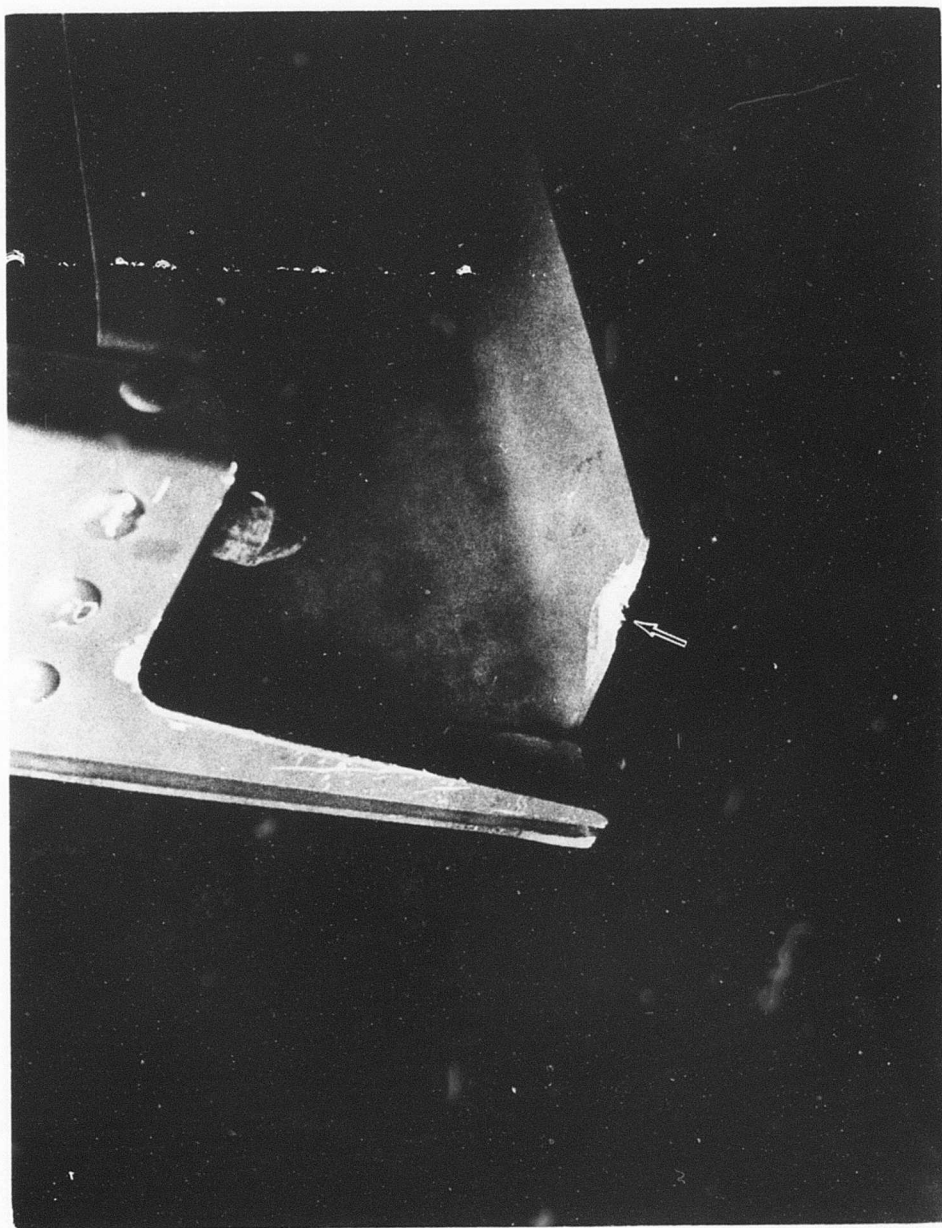
Figure 20. Main Rotor Pylon, Interference, Glass Shell.

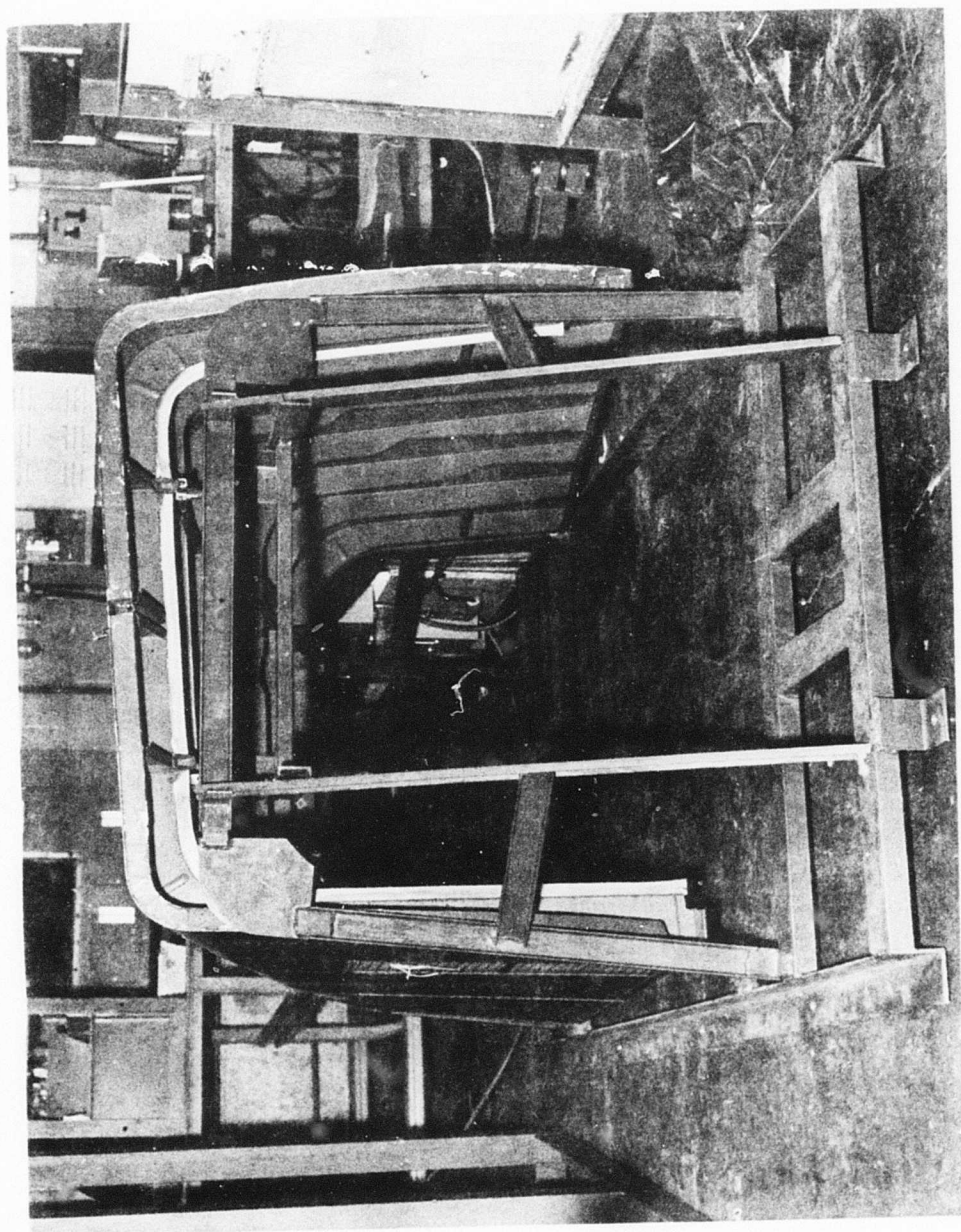
Figure 21. Main Rotor Pylon, Misalignment.

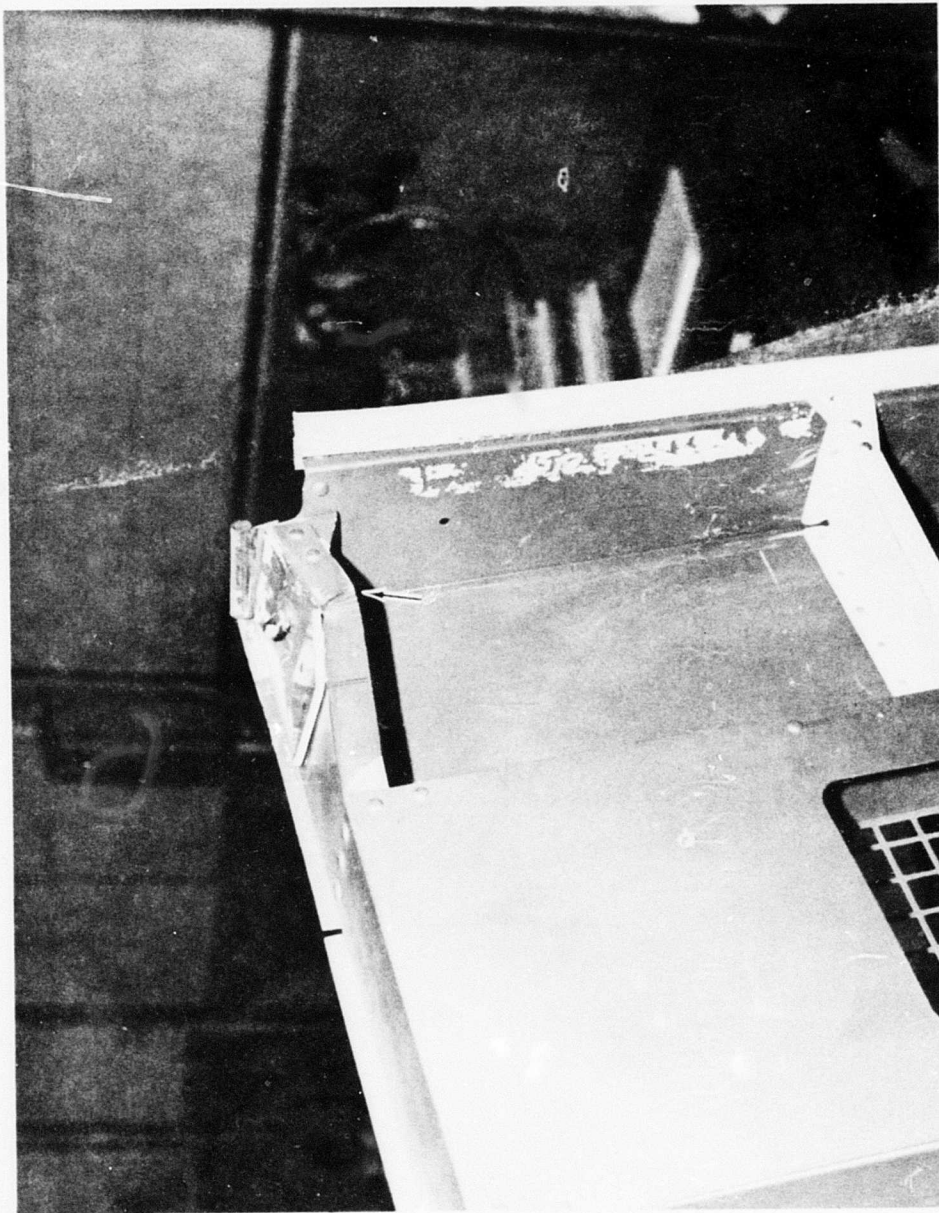
Figure 24. Main Rotor Pylon, Redesign, Alignment Pin Mount Damage.

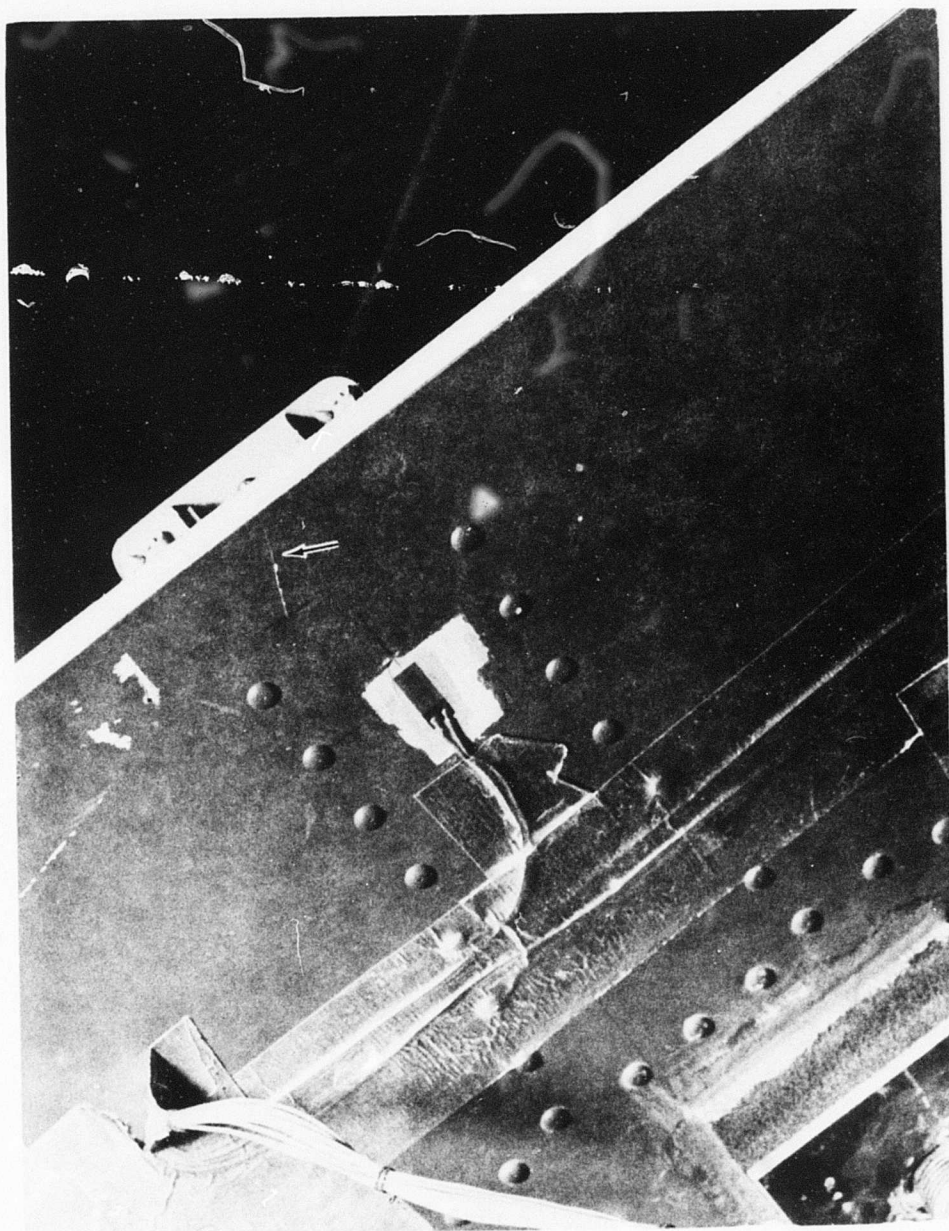
Unlike the other two test items, the vibratory loading on the door (Figure 27) resulted in fatigue cracks similar to field modes. The original design lower personnel door developed the cracks in the skin through the support

channels (Figures 28 and 29) at the latches in 175 hours of running. The redesigned door showed improvement. Although the same type of cracks appeared, they took longer (252 hours) and were smaller, not propagating as quickly.

Figure 28. Lower Personnel Door, Original, Fatigue Skin Crack.

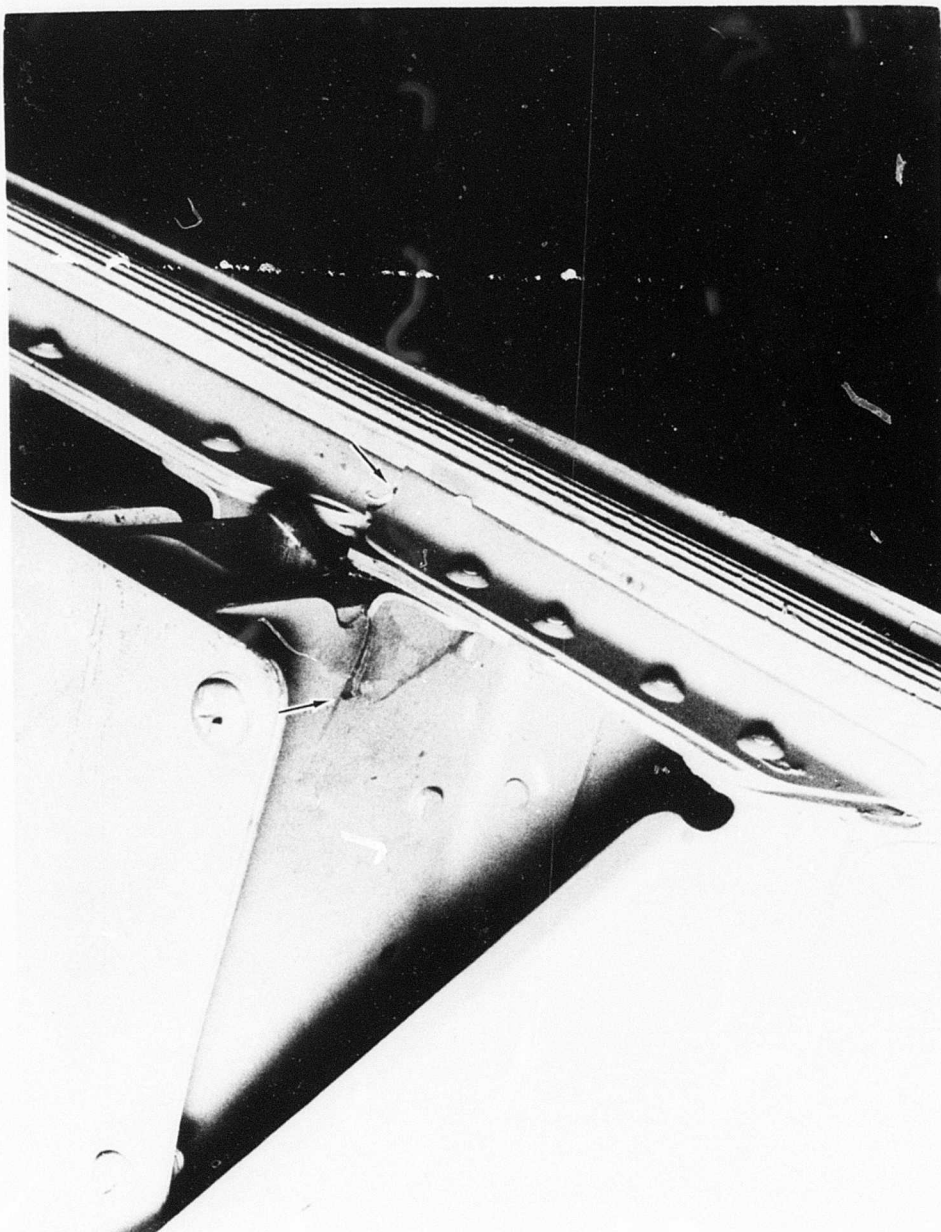
Figure 29. Lower Personnel Door, Original, Cracked Support Channels.

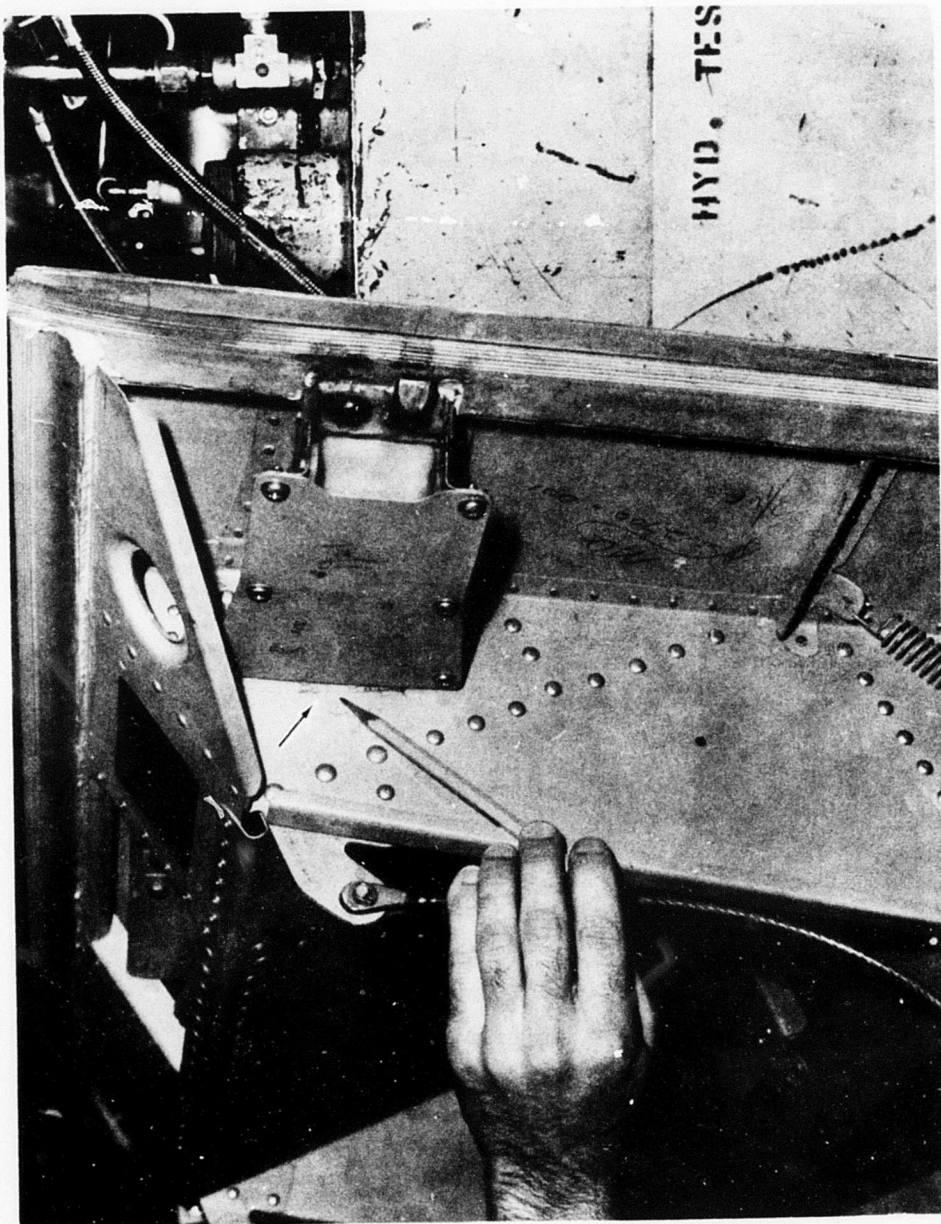
Figure 32. Lower Personnel Door, Side Beam Fatigue Crack.

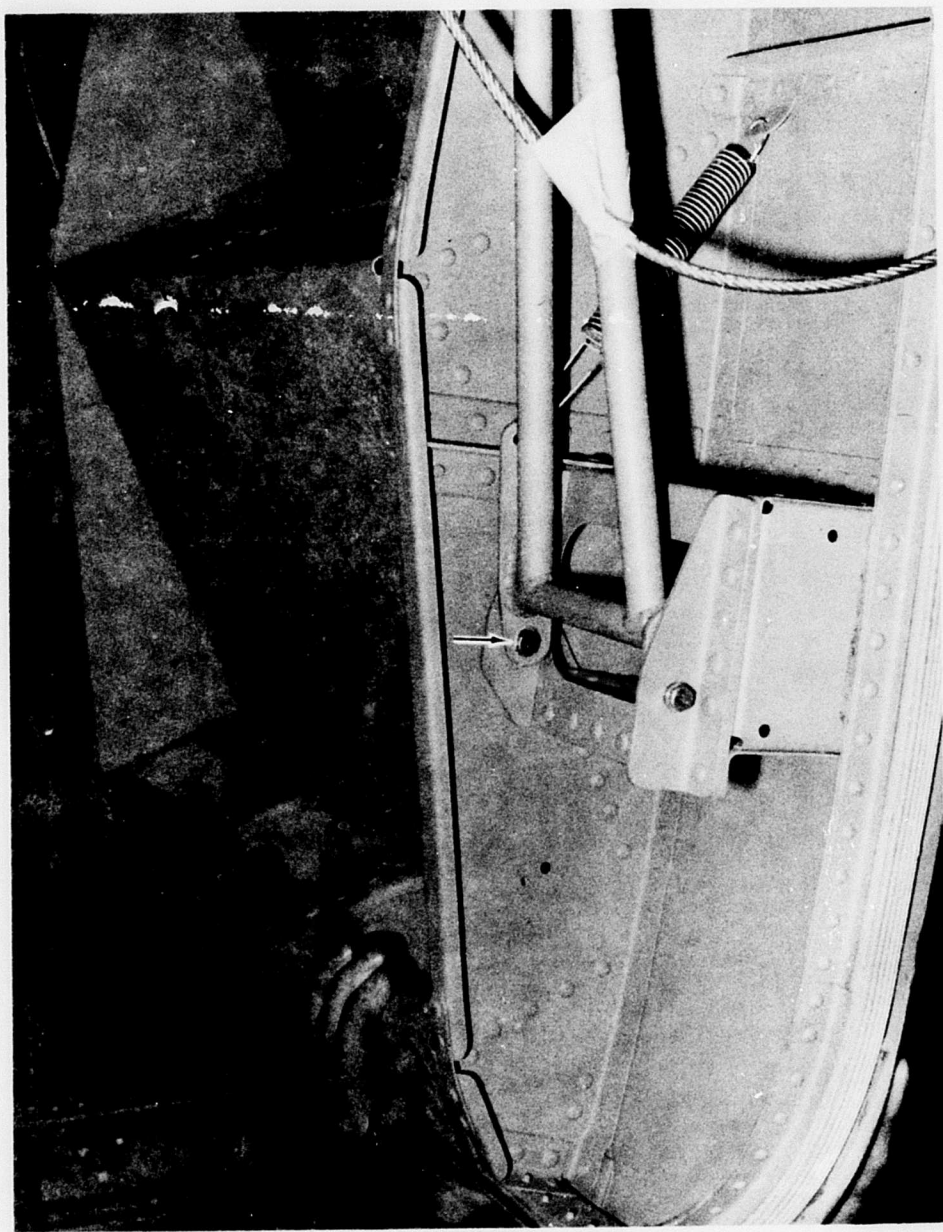
Figure 34. Lower Personnel Door, Original Support Assembly Damage.

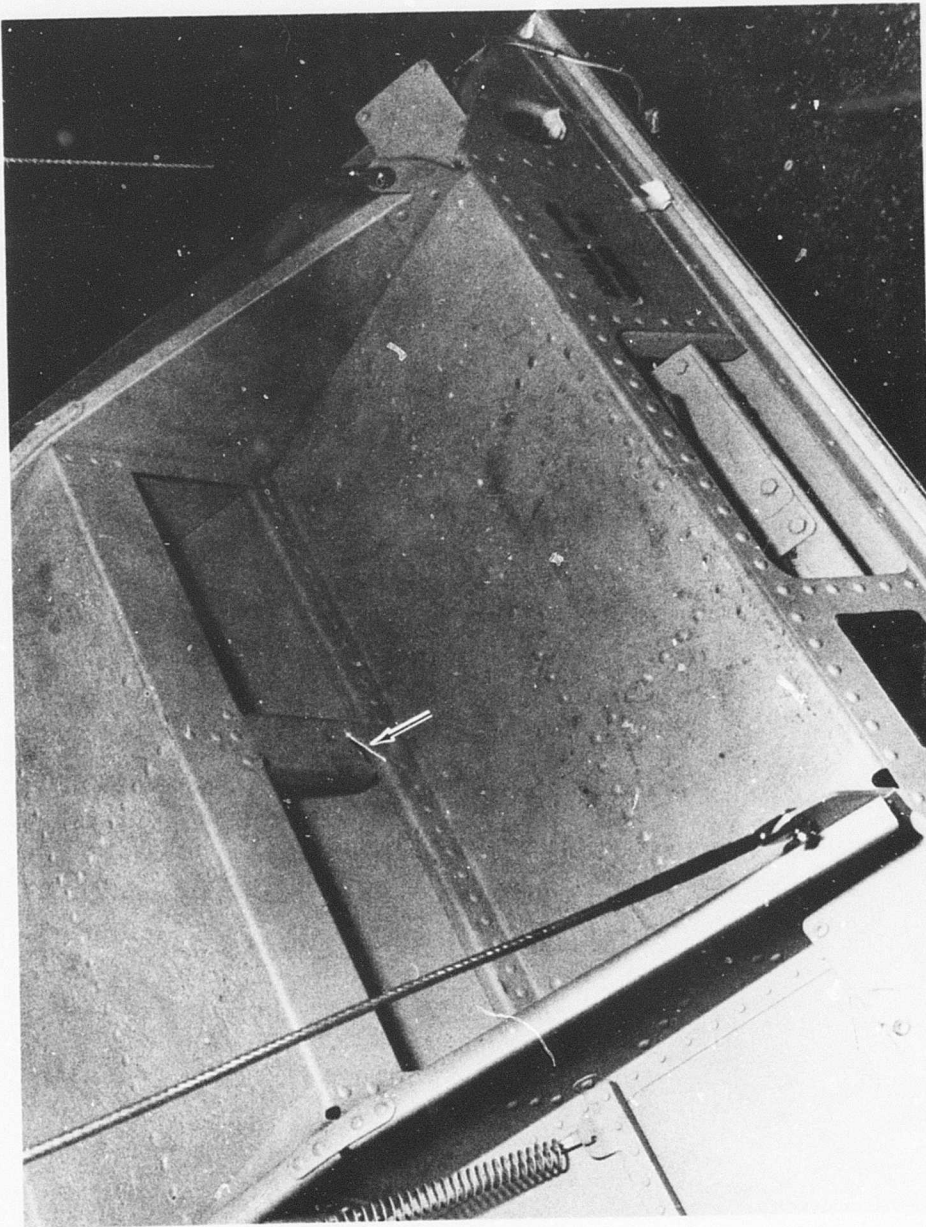
Figure 37. Lower Personnel Door, Original, Riser Fracture.

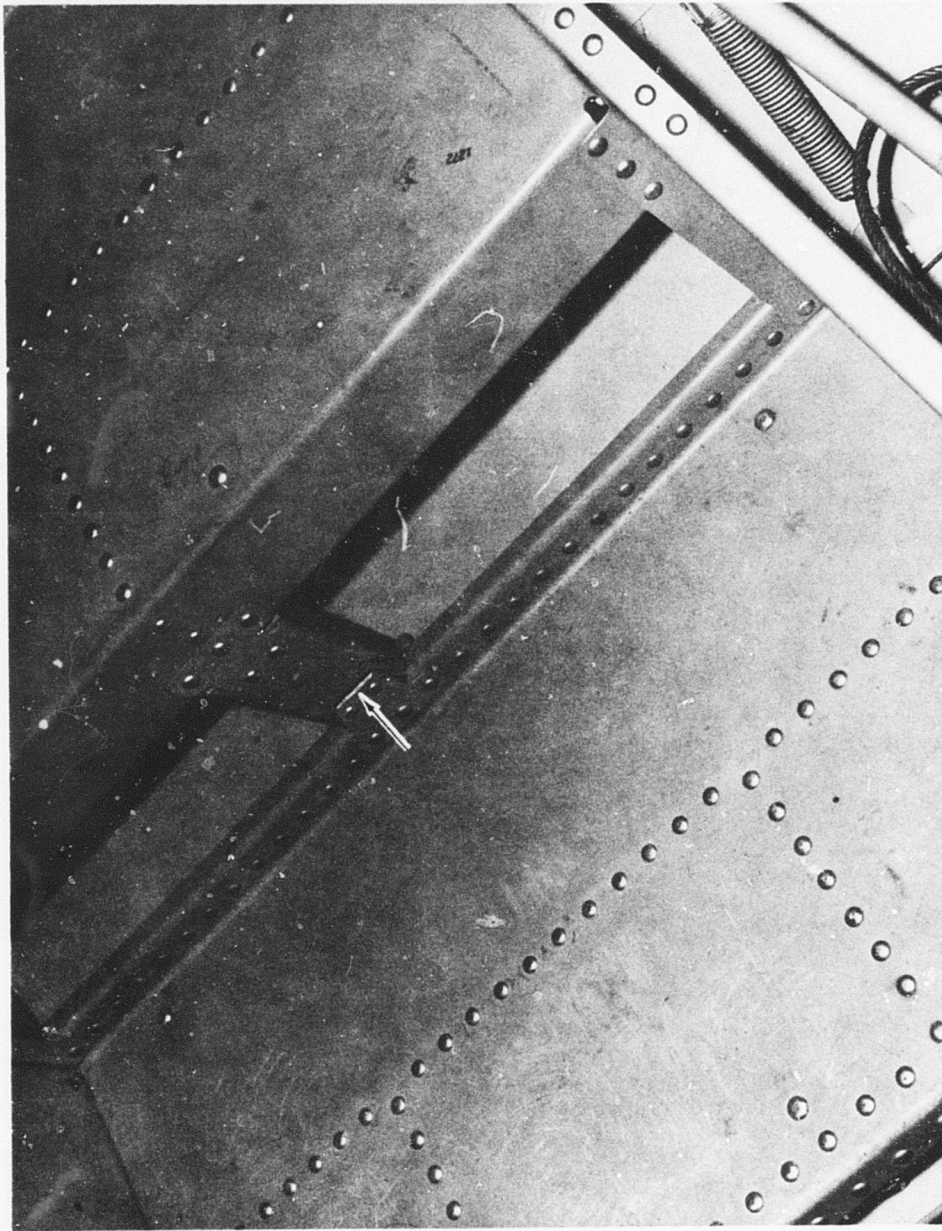
Figure 38. Lower Personnel Door, Redesign, Riser Fracture.

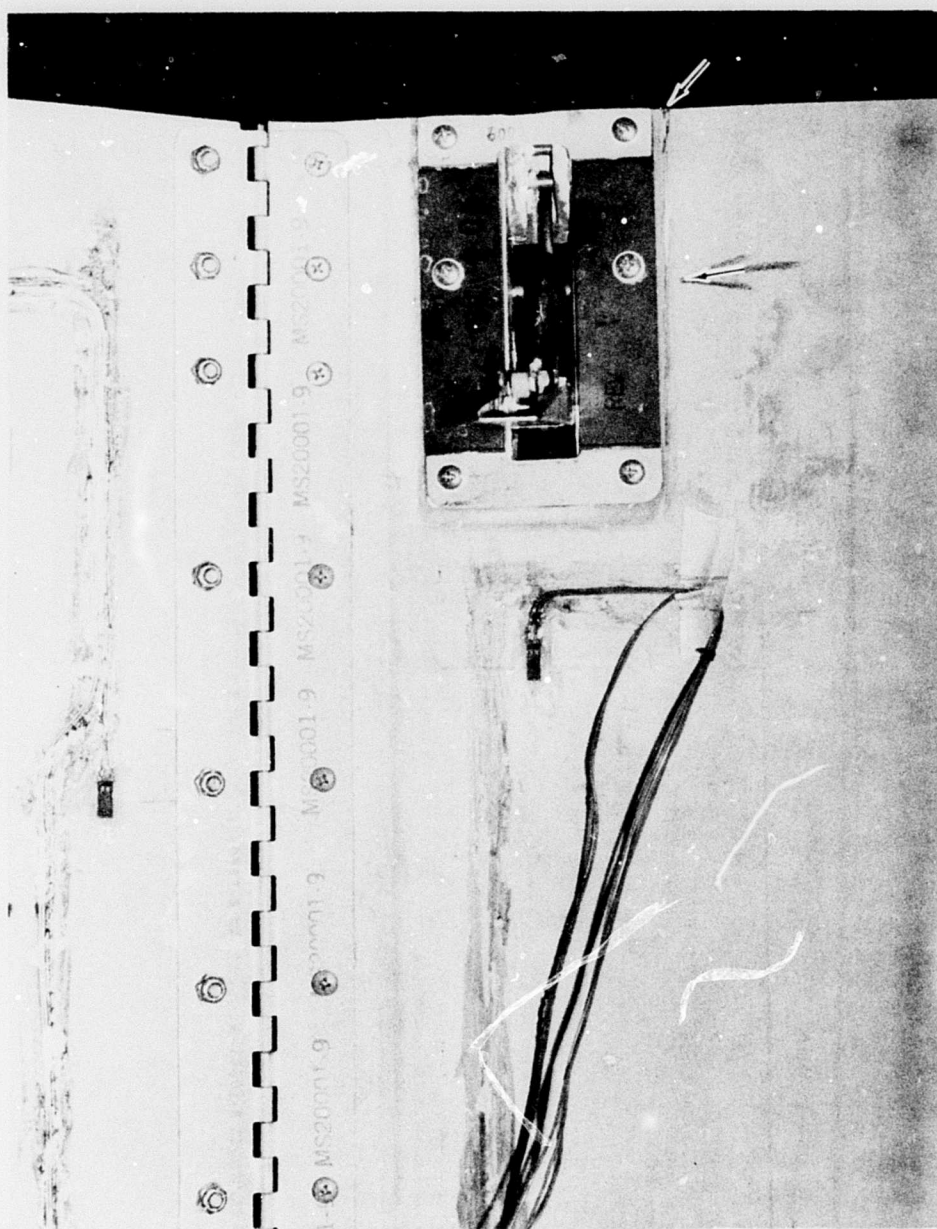
Figure 43. Work Platform Assembly, Original, Crack.

The redesigned work platform assembly is expected to eliminate the delamination problem, as it is constructed of an aluminum and honeycomb structure rather than an aluminum and fiber glass laminate on a balsa wood core.

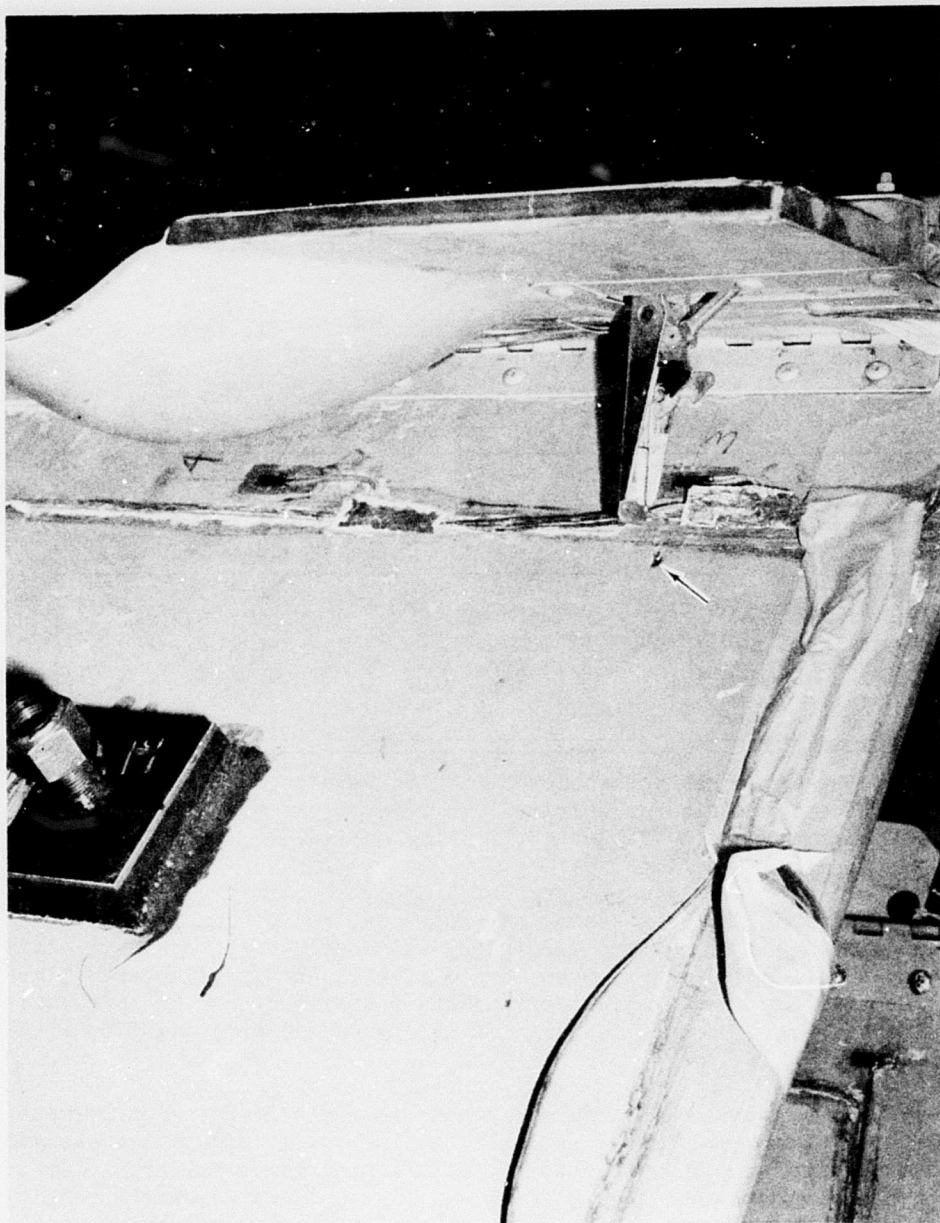
Figure 44. Work Platform Assembly, Redesign, Damage.

One damage mode which appeared on the redesigned work platform assembly, but not on the original, was the cutting through of the structure by the latch handles in the open, working position (Figure 44).
